Manhole Inspection Summary

Manhole # S15KK1008MH

Insp Date: **6/19/07 12:18 PM**

Location Address: **GREENSPRING AVE**

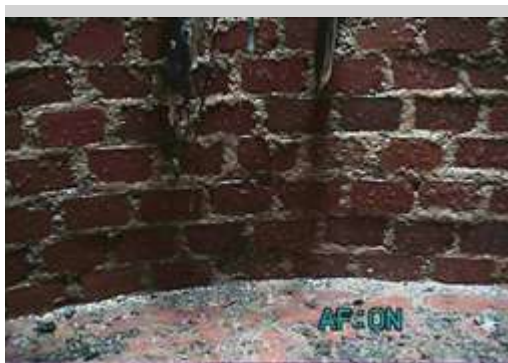
Defect

☐ Parged ☒ **Debris** (not Condition related)

Surcharge ☒ **Evidence Of Surcharge** Depth: **3** (ft.) ☐ Active Surcharge Present

Evidence of surcharge - Bench debris.

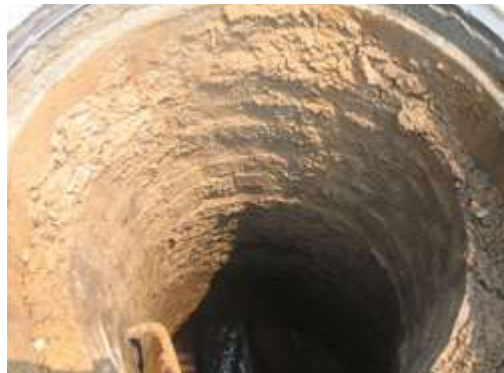
Defect

Condition: ☐ Sound ☐ Cracked ☐ Root Intrusion ☐ Loose Brick ☒ **Deteriorated**

Infiltration: ☐ None ☐ Joint ☐ Cracks ☒ **Mortar** ☐ Roots ☒ **Wall**

Barrel infiltration.

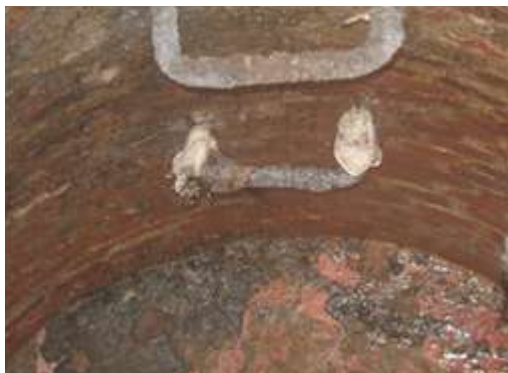
Defect

☒ **Leaks**

Infiltration: ☐ None ☒ **Joint** ☐ Cracks ☐ Mortar ☐ Roots ☒ **Wall**

Frame leaks. Frame offset. Adjustment and Barrel infiltration.

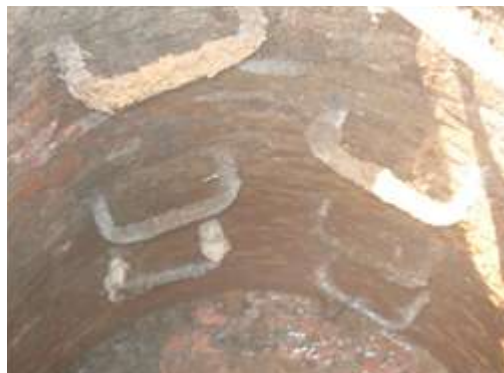
Defect

Evidence of surcharge - Bench debris.

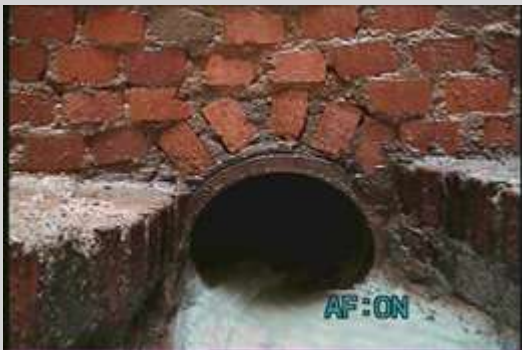
12 in. Circular Gravity Sewer Pipe Out @ 12 O'Clock

Barrel deterioration and infiltration.

Infiltration: **Evidence** Pipe Seal Cond: **Unknown**

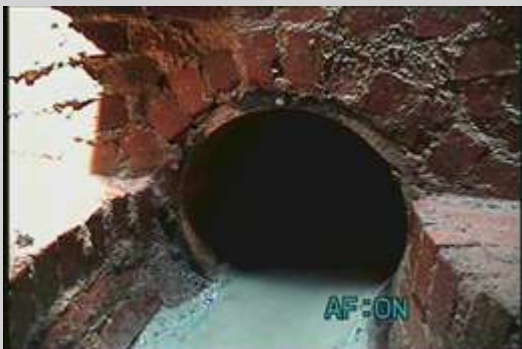
15 in. Circular Gravity Sewer Pipe In @ 8 O'Clock

Infiltration: **Evidence** Pipe Seal Cond: **Unknown**
